MAGNT RESEARCH REPORT No. 10
JANUARY 2005

THE HISTORIC SHIPWRECK *SS BRISBANE* (1874-1881)

A PLAN OF MANAGEMENT

DAVID STEINBERG

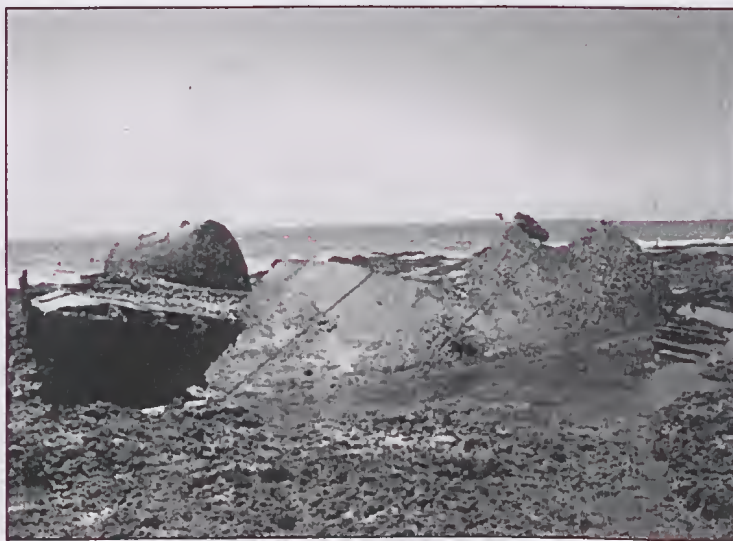
An observation of the wreck was made in 1881, the year it stranded, in which it was stated that the ship was tilted at an angle sufficient to make a length of the bow hang above the ground. Perhaps this section of bow viewed on the reef today constituted a part of the bow that hung above the reef. Eventually, under its own weight, the bow would have broken away from the keel of the ship and fallen to the ground.

Fig. 14. Bow (photo: D. Steinberg)

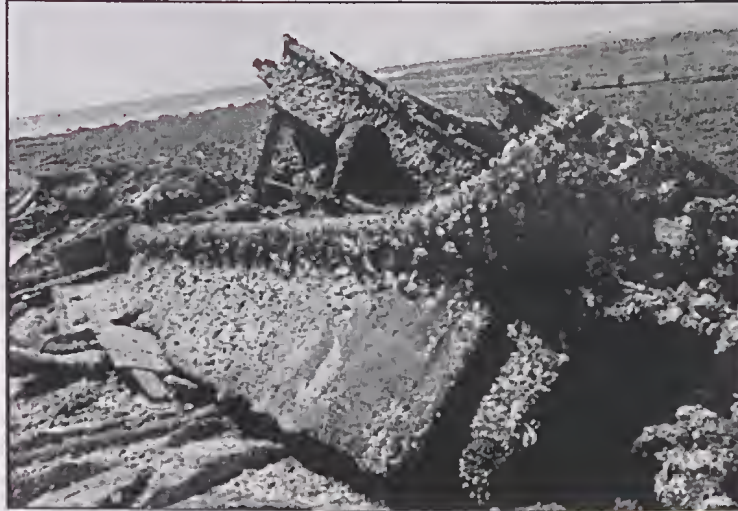
The keel or stem post. A long iron structure lies wedged into the bow section. It appears as two blade shaped lengths of sheeting joined together by a thick length of iron. It is either a section of the keel or stem post. It is more likely a portion of the keel, with both sides of the ship's outer hull still attached. There is not a keelson attached to this length of keel to support this argument. However it is less likely the stem post because a section of stem post attached to the bow is of a different thickness and width.

Fig. 15. Keel or stem post (photo: D. Steinberg)

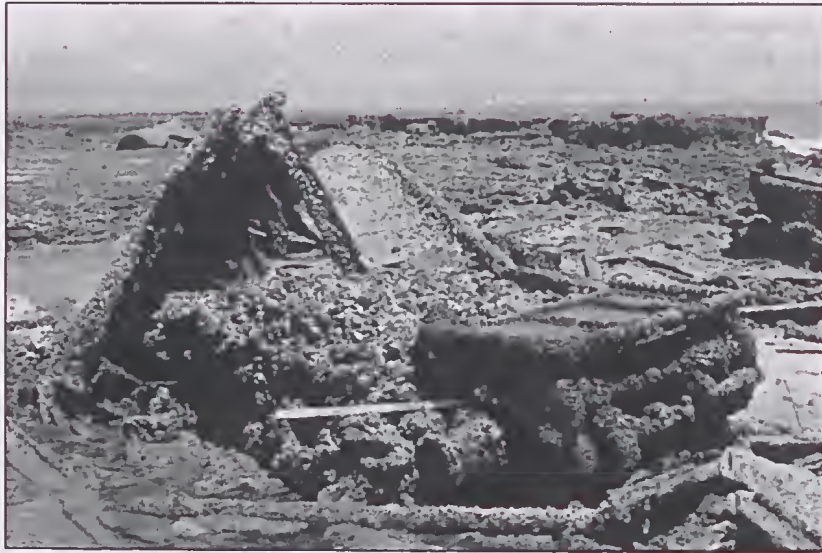
Directly behind (west) of the bow structure is a winch, a large mound of chain and a short section of the foremast. Although they are in close proximity to each other the chain itself is not wound onto the spool of the winch. It is unlikely that this winch was used to haul this chain as the windlass was better suited for that work. The winch sits upside down. The chain is a solid mass fused together by corrosion. It was once stored inside a sub-deck forward chain locker, however there is no evidence of the locker fixed or corroded into this mass of chain. The section of mast must have been torn away from the rest of the foremast by a sudden physical action rather than slow progressive corrosion. It is unlikely that its present location demonstrates where the foremast originally collapsed.

Fig. 16. Winch and chain (with bow in background) (photo: S. Jung)

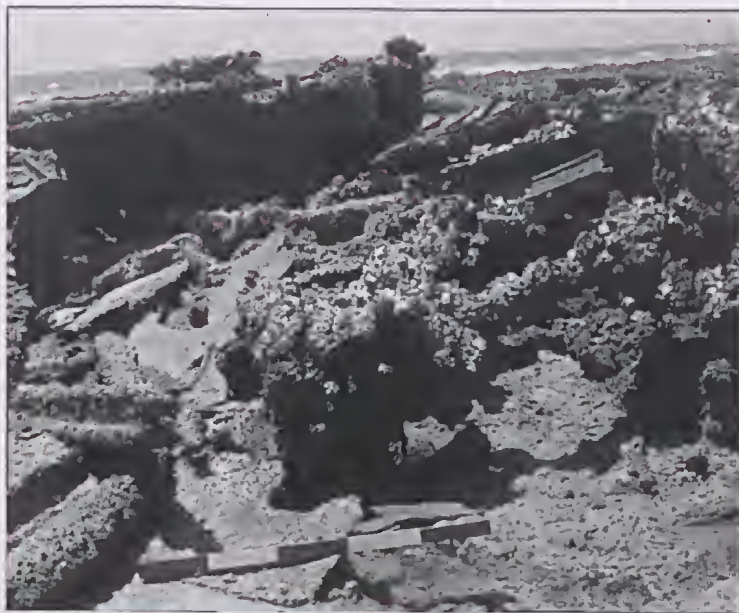
Davits and Capstan. Just forward (east) of the bow by a few metres are four boat davits and the capstan. Davits were the small hook-shaped cranes that were used to secure and lower the ship's boats and raise the anchors from the hawse to the deck. The capstan was a large spool which sat on the forward deck and guided the chain to and from the locker. The capstan's shaft has been broken along its length, however the heavier and stronger capstan spool still remains attached to the shaft.

Fig. 17. Capstan and davits (in foreground) (photo: S. Jung)

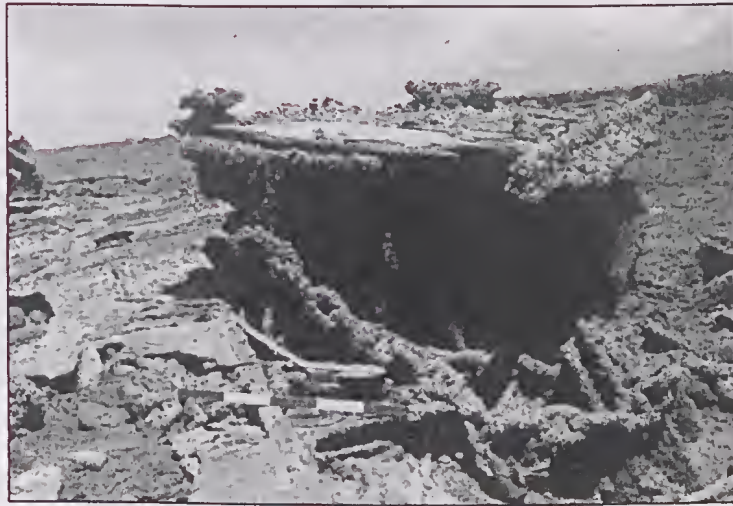
Also located close to the bow is a windlass, which, like the smaller sized winches, was a steam driven pulley. It can be recognised as a windlass because it is substantially larger than the two remaining winches and it has a length of chain which leads to a bower

Fig. 18. Windlass (photo: D. Steinberg)

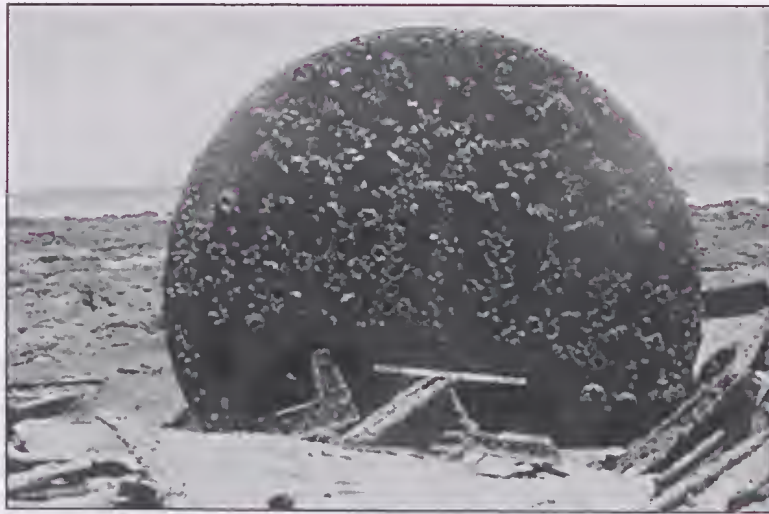
This particular boiler had been moved over 20 metres from its original deposition by wind and wave action. The boiler has been rolled in an easterly direction, suggesting that it was extreme north-west monsoonal weather that moved it.

Fig. 19. Main boiler face (photo: D. Steinberg)

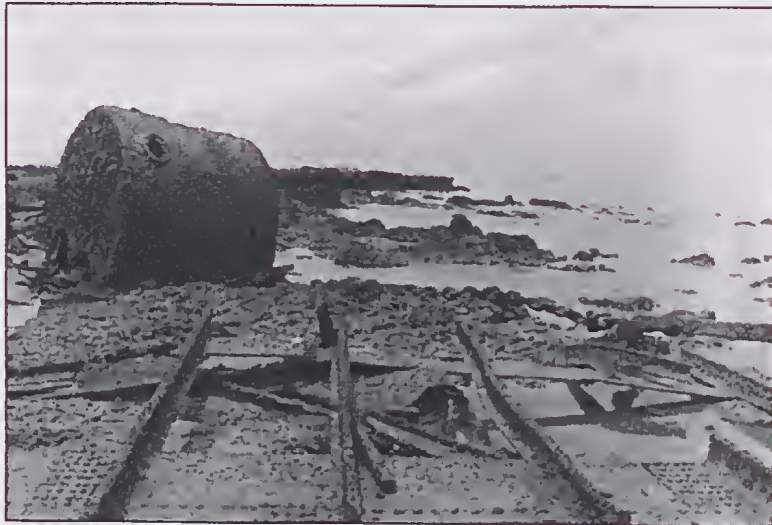
Figure 20 shows structural debris that is most likely the remains of deck flooring opposed to hull structure. The deck debris appears as iron sheets riveted to a framework of supportive beams. There are regular rectangular spaces which were either hatches through the floor or areas covered with teak decking.

Fig. 20. Main boiler and deck debris (photo: D. Steinberg)

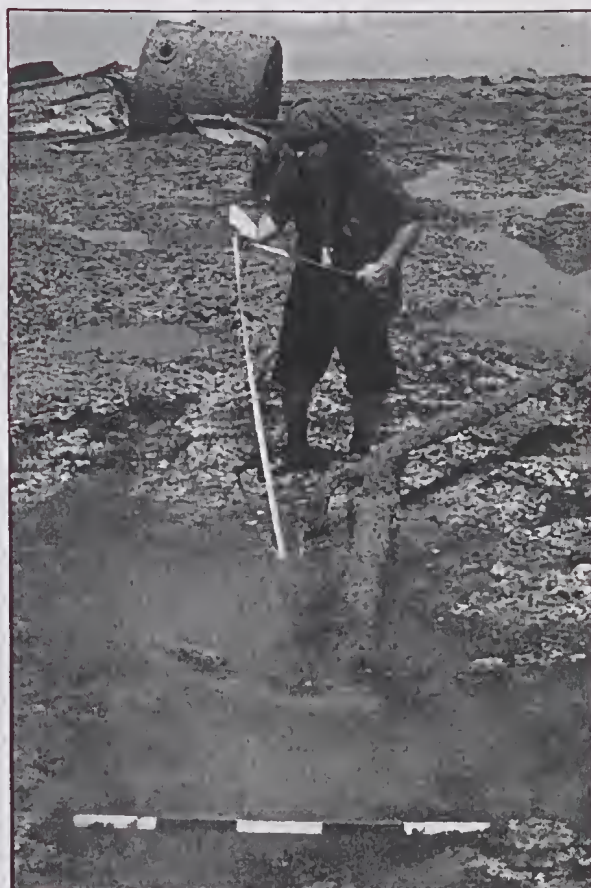
Figure 21 shows the smaller of the two complete anchors, which is either a stream or ketch. Note that this anchor has a ring at the end of the stock but no chain connected. Also one end of the stock has been broken off and the other end twisted back.

Fig. 21. Stream or ketch anchor (photo: S. Jung)

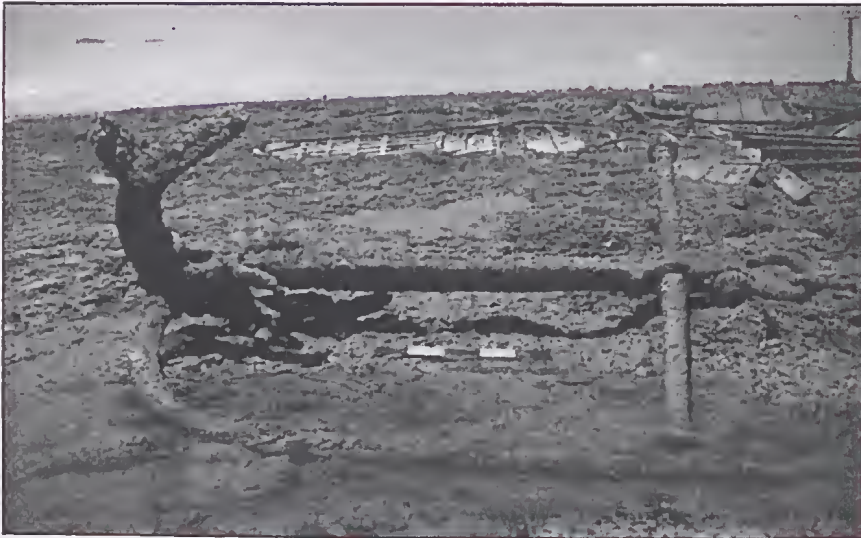
The bower has a large fluke that is bolted to the shank. Along the length of the shank (on both sides) is a fish-shackle, used to secure the anchor on deck. The anchor has chain attached and this chain leads to the windlass. It is unclear whether the anchor was deliberately thrown overboard once the ship became stranded or if it fell as part of the bow breaking up.

Fig. 22. Larger bower anchor with davit (photo: S. Jung)

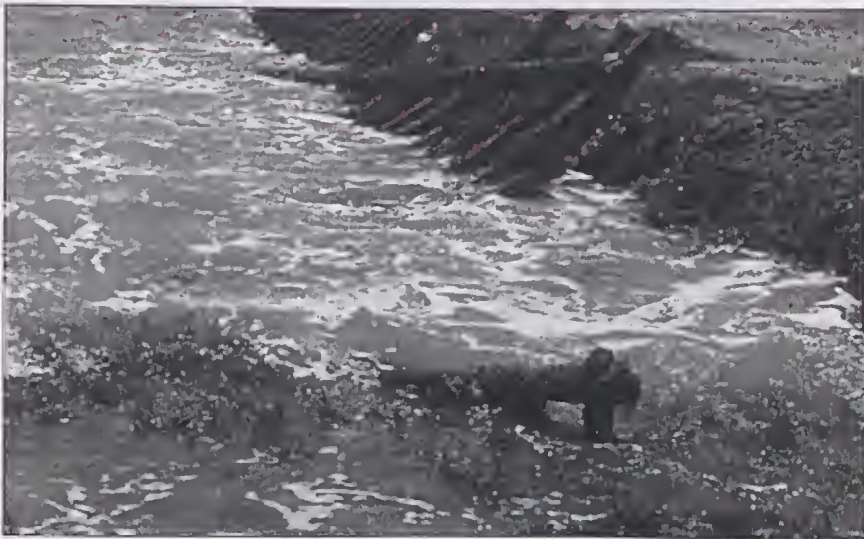
Fig. 23. The stock of a broken anchor (photo: S. Jung)

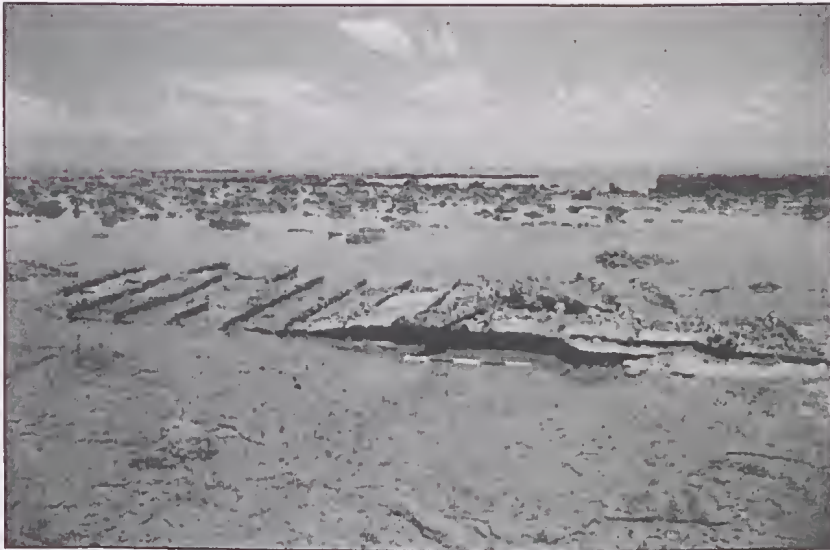
Some of the hull sections show the internal rib structure face up. Other examples have the outer side exposed. A section of gunwale with a bollard and a portion of deck are also located in this area.

Fig. 24. Sections of hull east of the bow (photo: D. Steinberg)

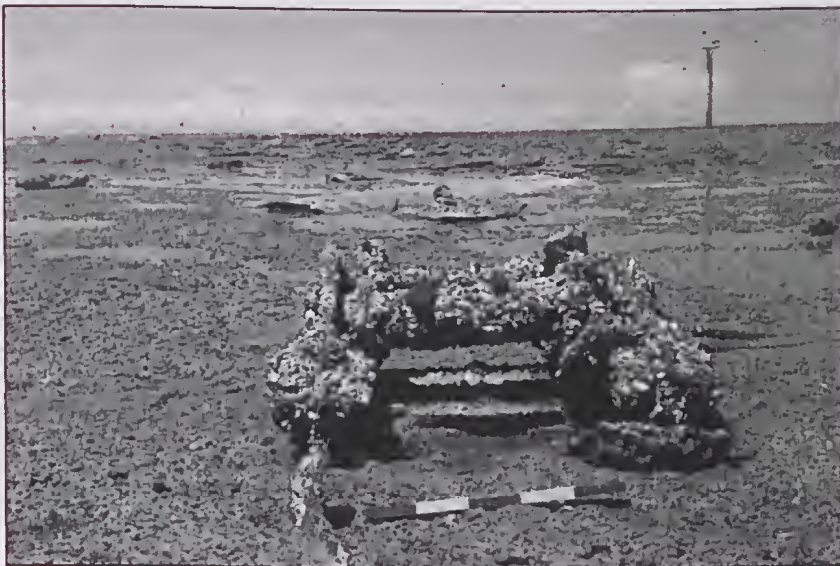
The image below shows the winch located east of the bow, and its position in relation to the navigation beacon. The winch is heavily encrusted with marine growth, unlike other features such as the boilers. The diagnostic features that identify this feature are the squat frame, the warping ends (spools), wheels and horizontal rods.

Fig. 25. Winch (photo: D. Steinberg)

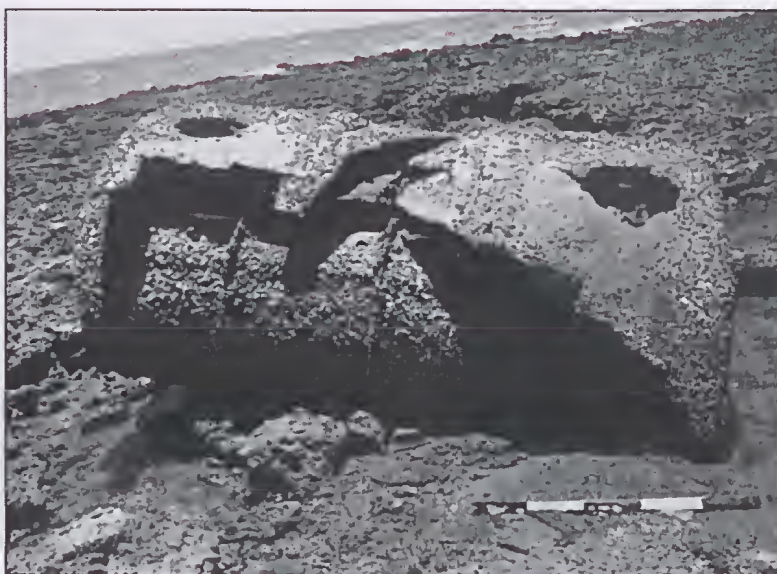
The donkey boiler located south-east of the bow is shown below. Its outer plating has in places been torn away and so the two cylindrical chambers are visible for inspection. Neither furnace doors or control levers remain on this boiler.

Fig. 26. Donkey boiler (photo: D. Steinberg)

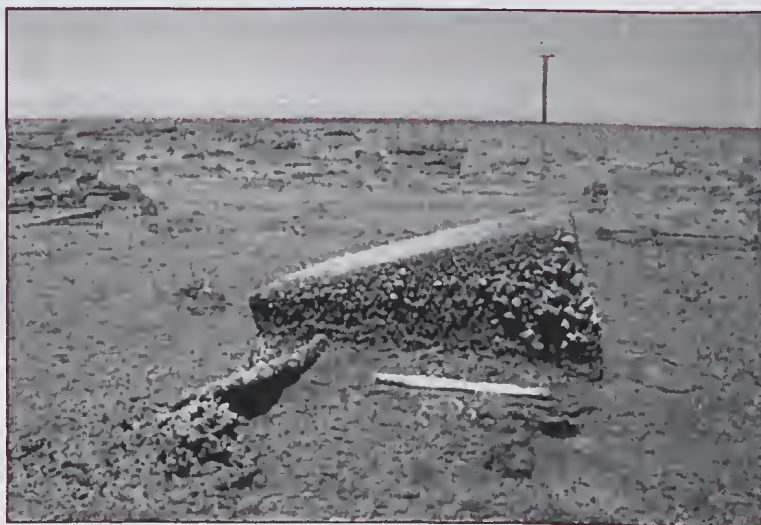
One rectangle shaped tank is located approximately 50 metres east of the bow. The oval hatch door of the tank is absent and two inlet/outlet valves are located on the same side. The dimensions of this storage tank are 1.2 metres x 2.3 metres. It is partly buried, making it difficult to measure a height (or thickness).

Fig. 27. Storage tank (photo: D. Steinberg)

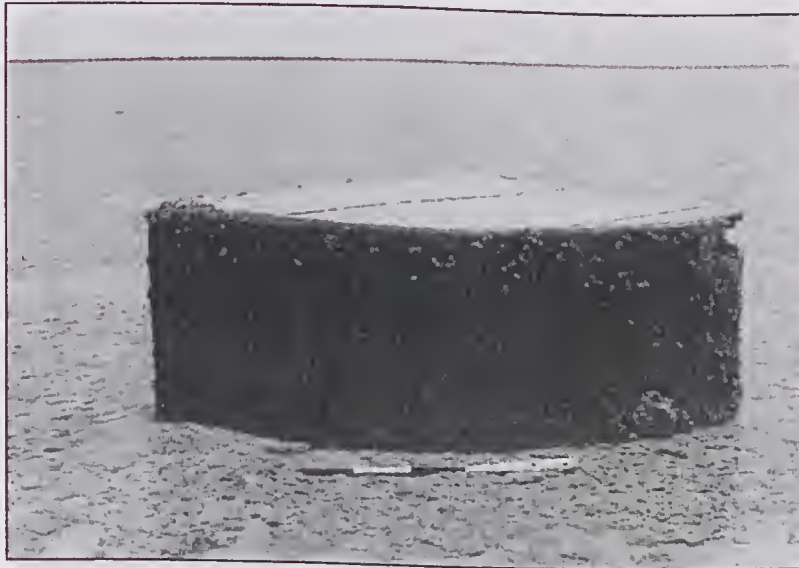
A second tank is located approximately 300 metres from the bow in a south-south-east direction. This tank is wedge shaped suggesting that it was built to fit into a wedge shaped cavity, for example the forward curvature of the bow. Interestingly, the top surface, as it lies on the reef, is made of three overlapping sheets. This may have been a technique to increase surface strength. The length of each of the perpendicular sides is 1.63 metres. The width (height) of the tank is 80 centimetres in length.

Fig. 28. Curved storage tank (photo: D. Steinberg)

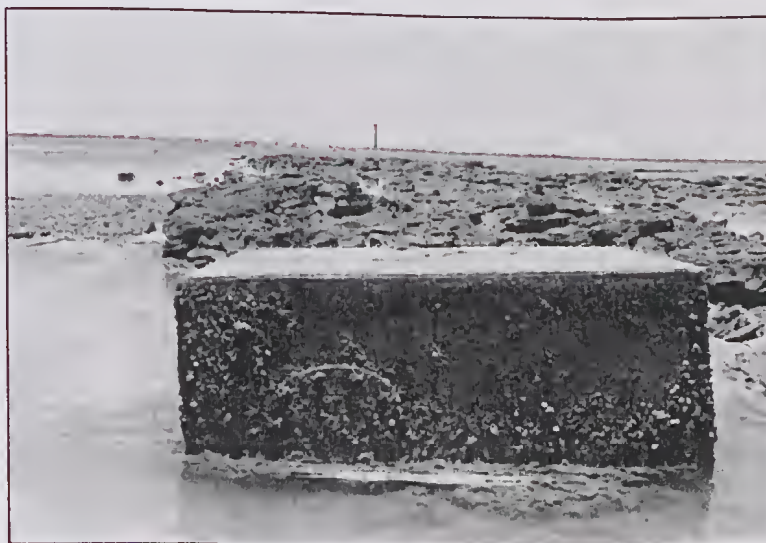
A third storage tank is located over 400 metres away from the bow in a south-east direction. This tank is rectangle shaped and measures 1.96 metres x 2.30 metres x 0.83 metres. The larger tank surfaces consist of iron sheets fixed side by side, rather than in an overlapping style. Unlike the smaller rectangle shaped storage tank described earlier, the oval hatch is sealed shut.

Fig. 29. Larger storage tank with beacon in background (photo: S. Jung)

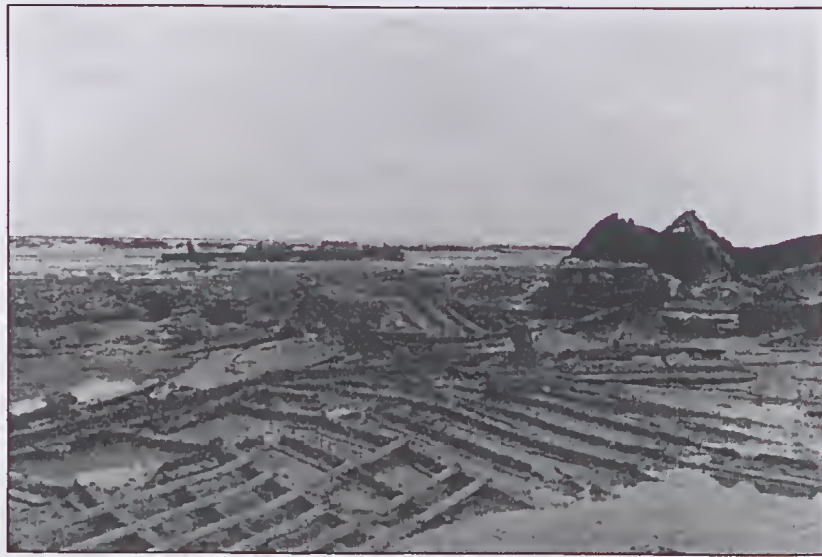
It is logical that this section of the wreck, over the stern section, has been broken up and scattered, as this area of reef experiences the full force of breaking waves and strong north-west winds.

Figure 30 shows the greatest concentration of hull plating in this area.

Fig. 30. Hull debris aft of the bow

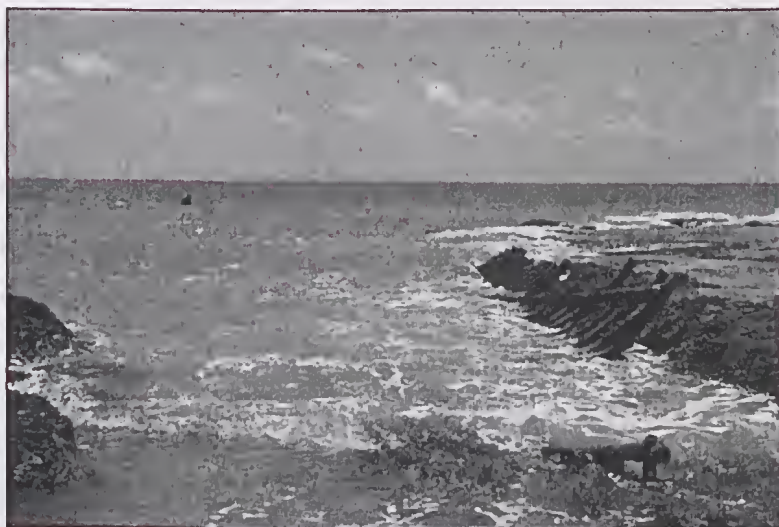
Figure 31 shows the water's edge at a spring low tide. A stock of an anchor and the rib structure of the lower port side are visible in the foreground. In the background the stern steering mechanism protrudes from the water. The anchor stock to the stern steering mechanism clearly marks a specific section of the shipwreck. This section constitutes what was the stern to the midships of the *SS Brisbane*. This wreckage is not only a separate section of the shipwreck, because it is located below the low tide mark and therefore only accessible through scuba diving. It is also useful to consider it separate because the degree of hull integrity here differs greatly to that seen in the rest of the site.

Fig. 31. Exposed ribs and stern steering mechanism (photo: S. Jung)

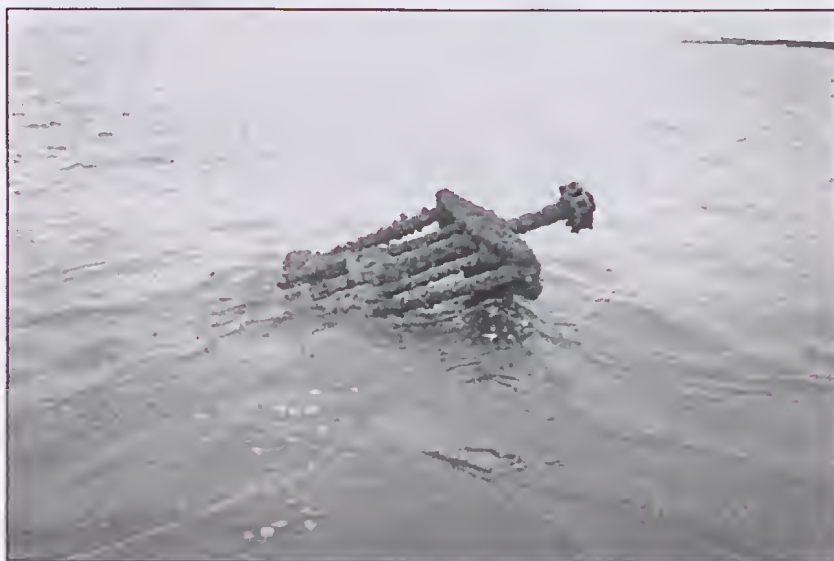
As the drawing suggests, the propeller and rudder are still attached to the stern. The propeller is four bladed and made of iron. The rudder is turned to starboard. As demonstrated on the diagram, there is no stern wheelhouse on the wreck. The tallest feature of the stern is the stern steering mechanism, which is attached to the sternpost. The steering crank was once attached to an aft wheel, which was likely used only if the primary mechanism failed. Below the steering mechanism there are a few beams attached to the sternpost. These are likely remains of the transom structure. Figure 33 shows the stern steering mechanism.

Fig. 33. Steering mechanism attached to stern post (photo: P. Clark, 1990)

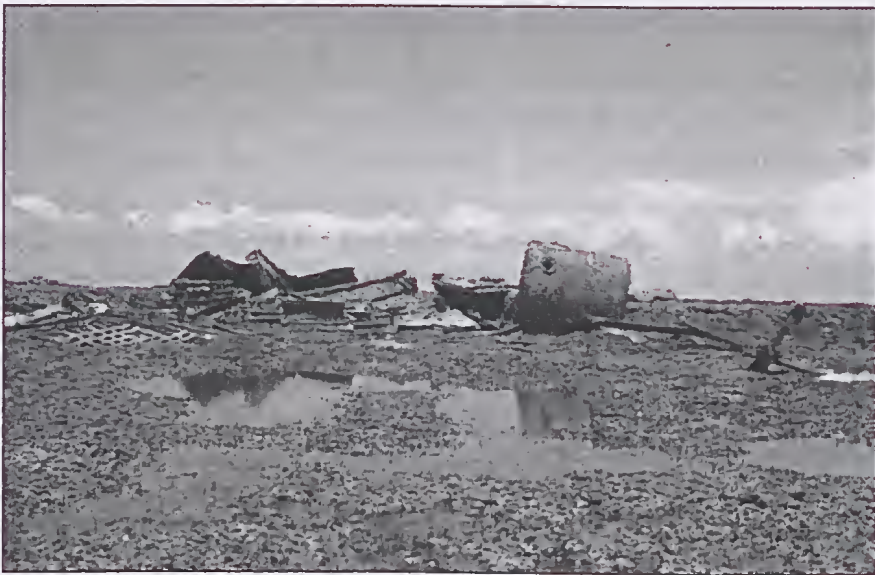
Figure 40 shows the exposure of various cultural material in the intertidal zone at 0.24 metres tide. Figure 41 was taken at the same time but the photographer turned on the spot 180°. It shows the spring low tide line and wreckage descending into the water.

Fig. 40. Cultural material at 0.24 metres tide (photo: S. Jung)

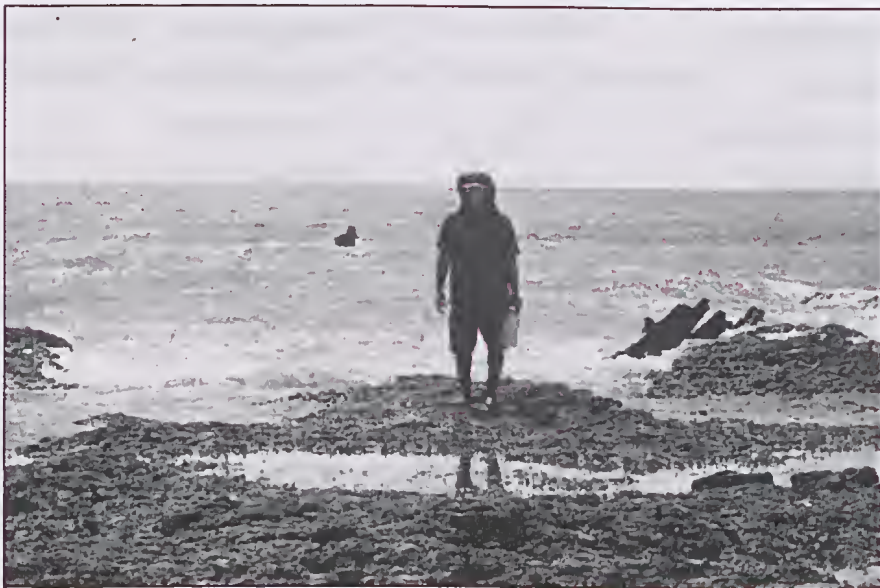
Fig. 41. Midsection and stern at 0.24 metres tide (photo: S. Jung)
